Manhole Inspection Summary

Manhole # S27I__003MH

Insp Date: **5/29/08 9:11 AM**

Location Address: **901 Hollins St**

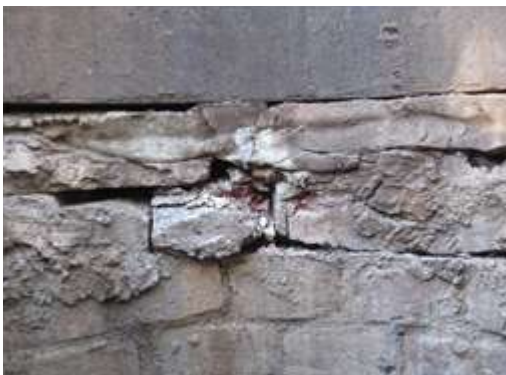
Defect 4

Condition: ☐ Sound ☒ **Cracked** ☐ Root Intrusion ☒ **Loose Brick** ☐ Deteriorated

chimney loose bricks

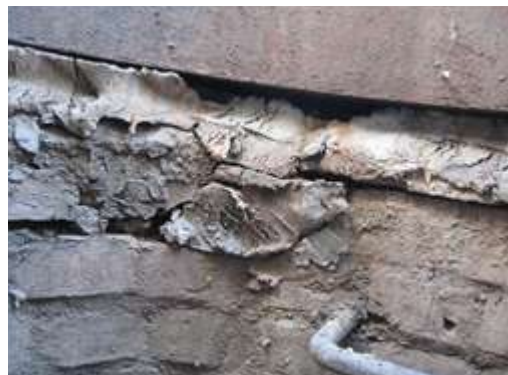
Defect 3

Infiltration: ☐ None ☒ **Joint** ☐ Cracks ☐ Mortar ☐ Roots ☐ Wall

missing mortar, signs of infiltration

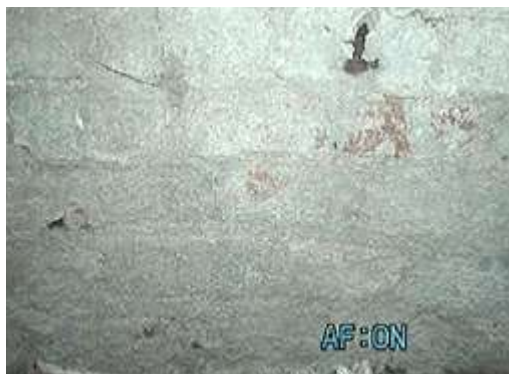
Defect 2

Condition: ☐ Sound ☒ **Cracked** ☐ Root Intrusion ☐ Loose Brick ☐ Deteriorated

cracked barrel

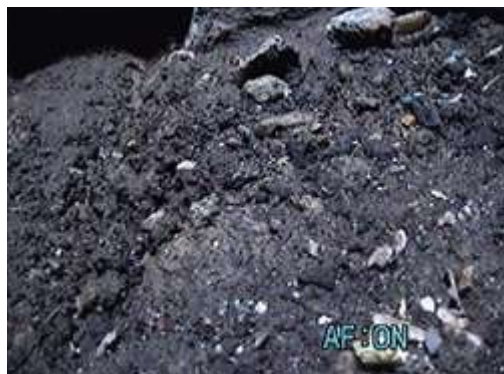
Defect 1

Condition: ☐ Sound ☐ Cracked ☐ Root Intrusion ☐ Deteriorated ☐ Leaks ☒ **Debris**

debris cond bench
